The 606-Bloomingtondale Trail | Viaduct Repairs

The Outstanding Repair & Rehabilitation Project

606-Bloomingtondale Trail | Viaduct Repairs

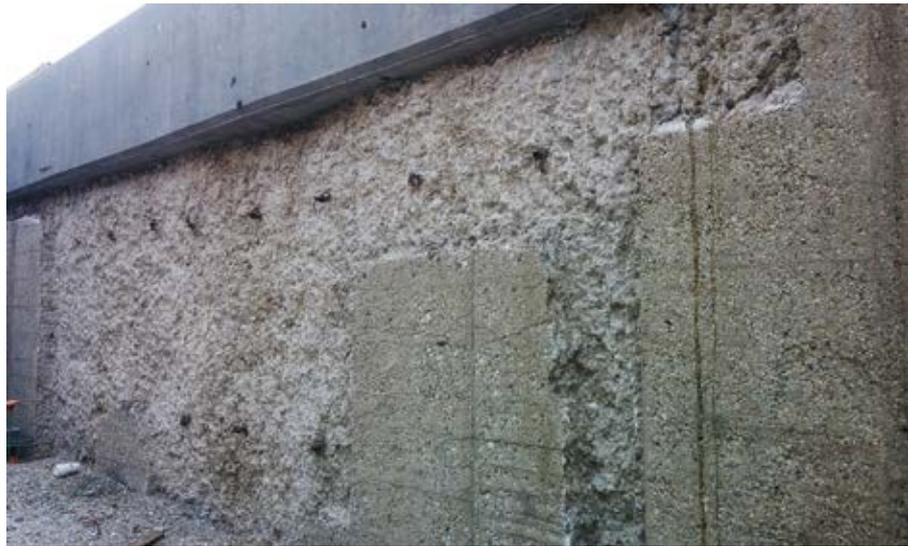
Fig. 1: Repair areas were found to be not only much larger in the field but also deeper than was called out on the plans and also lacking any reinforcing bar

With frost already present and frigid cold temperatures soon to be upon Chicagoland, ACR devised a plan to keep the project moving forward through the winter months. This plan consisted of performing the necessary concrete removals at the bridge locations followed by fully enclosing and heating the structures for shotcrete work to proceed. Along with a late start in the year and the cold weather setting in quickly, this project had a variety of obstacles, including access into heavily congested neighborhoods and residents' properties, repairs during limited closures of main thoroughfares, and a structure that was in much worse shape than originally anticipated (Fig. 1).

Upon commencement of the project, ACR realized that the bridges were in far worse condition than shown on the plans. Quantities immediately began increasing, as did the depths of the repairs, due to the fact that these walls were constructed with 1 in. (25 mm) unwashed river rock aggregate and without reinforcing steel. It was imperative to maintain excellent communication with the general contractor and the owner's engineers to verify work to be done and any additional repair steps to be taken, such as the addition of reinforcing bar, shoring, and identifying areas of complete deterioration requiring full replacement.

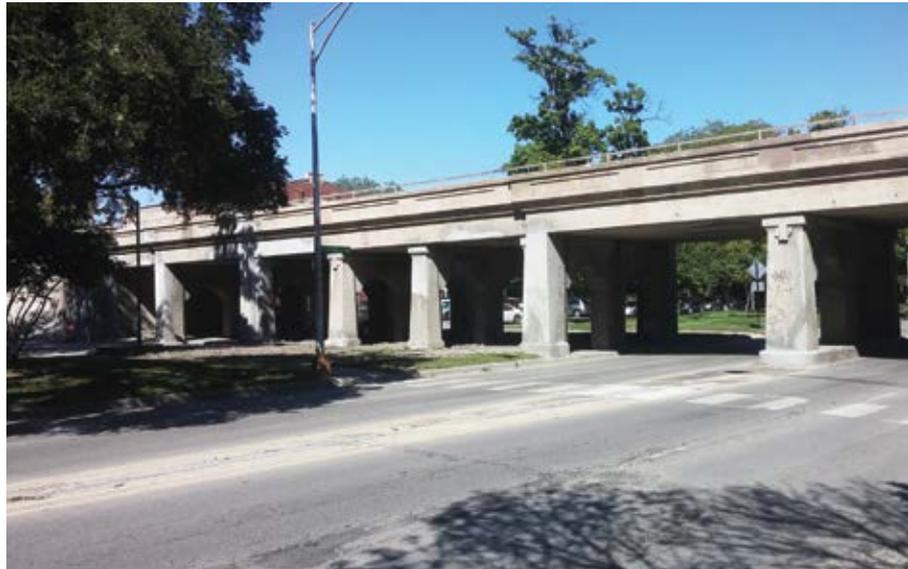
Fig. 2: Repaired 11 piers spanning 250 ft (76.2 m) over six lanes of traffic

encompassed the entire substructure including the wing walls, abutments, columns, and parapets. Each of the 36 bridges crossed two-lane streets, had three piers, and 15 columns. The trail also crossed five arterial streets, each with four lanes of traffic. At these locations there were four piers and 20 columns. At the longest bridge crossing, Humboldt Park Boulevard, it crossed six lanes of traffic, and there were 11 piers and 33 columns (Fig. 2).

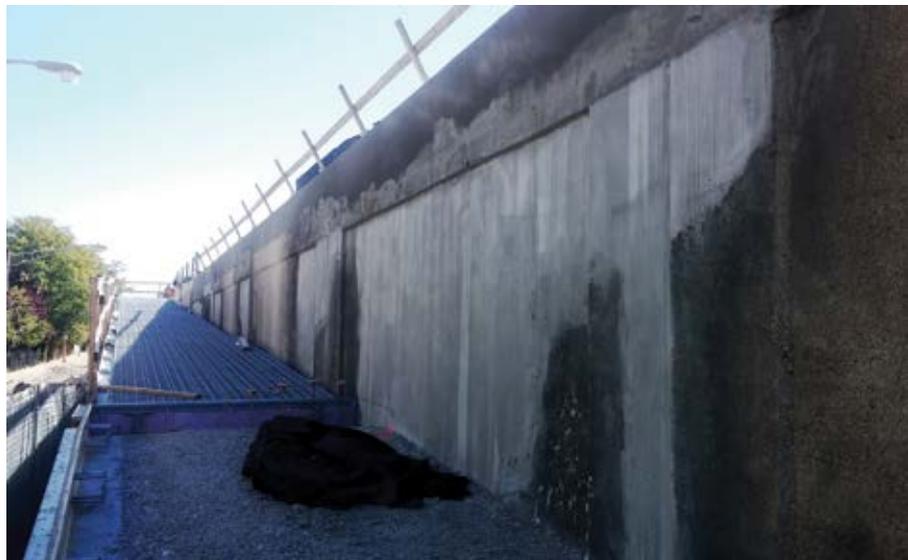
Fig. 3: Repairs completed at a newly installed pedestrian access ramps

Due to the congestion of the work area and the proximity to neighboring homes, parks, and schools, ACR sandblasted with water to keep dust to a minimum. ACR also cleaned up their work area at the end of every day to prework conditions, thus leaving the neighborhood safe for pedestrians and vehicle traffic (Fig. 3).

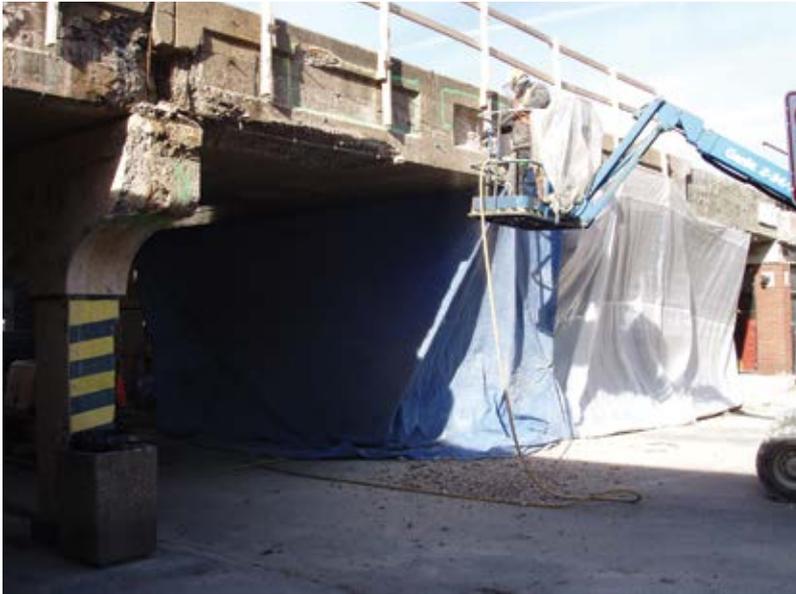
Fig. 4: Heated enclosures were installed on portions of bridge during winter months

already setting in. ACR devised a comprehensive plan for dealing with the upcoming winter months to accommodate low temperatures of up to -40°F (-40°C) wind chill temperatures. Each bridge was wholly enclosed using heavy-duty, fire-retardant tarps (Fig. 4 through 6). ACR also deployed large propane heaters to ensure proper ambient and substrate temperatures. Where full road closures were necessary, ACR was allowed a maximum of 2 weeks to complete the work on the specific bridge, including 7 days for curing, to satisfy the restrictions of the City of Chicago permits for street closures. ACR also used heaters to keep the water warm for mixing and torpedo heaters to warm the skids of pre-bagged material and the staging area. ACR used both infrared and standard

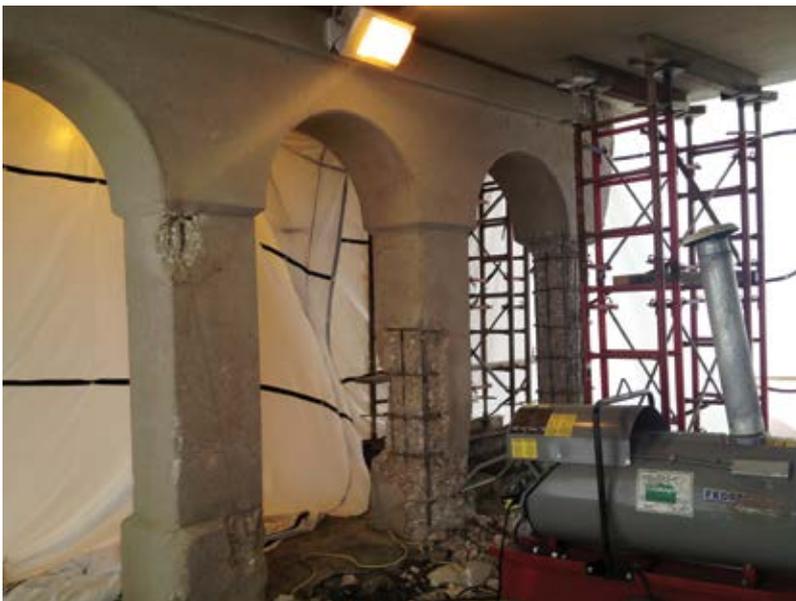
Fig. 5: Large propane heaters kept temperatures inside enclosure within specifications during cold winter months

thermometers to confirm the temperature of the substrate, water, pre-bagged material, and mixed material stayed at or above the specified minimum temperatures. The temperatures were recorded on quality control checklists every hour to document ACR's ability to maintain a high-quality shotcrete mixture. ACR's plan succeeded in providing quality repairs while allowing the project to progress through the brutal Chicago winter.

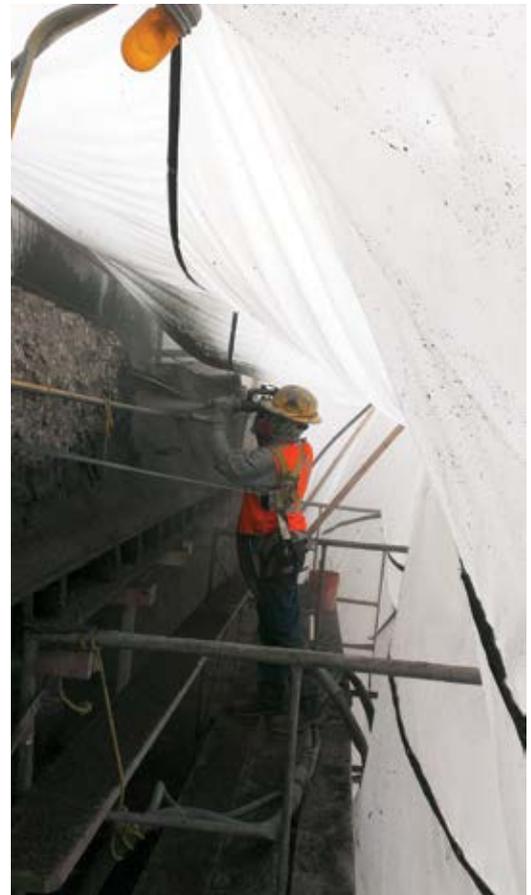
Fig. 6: Shotcrete placement inside a heated bridge enclosure

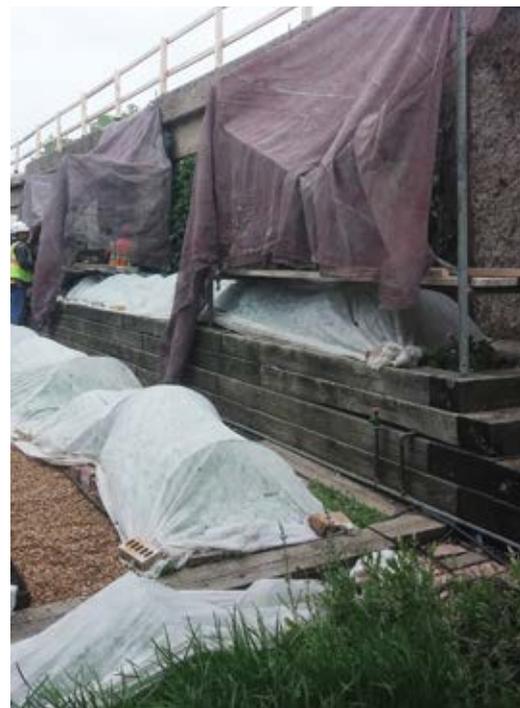
Fig. 7: Elaborate gardens of homeowners required covered repair areas that needed thorough planning, preparation, and coordination

Specifically, one of the yards ACR needed to access housed a picturesque koi pond and an herb garden owned by a well-known chef. This garden is closely tended by a professional gardener, and the harvest is used in several restaurants (Fig. 7). Thus, ACR had to deploy multiple levels of protection for the plants and planters from dust, debris, and overspray. Further, the retaining wall next to this garden was covered in decorative vines, and ACR had to coordinate with the chef's gardener to ensure proper pruning or removal without unnecessary damage to the surrounding foliage. In other areas, ACR had to install temporary framing on the outer edge coupled with protective mesh and tarps to ensure that the shotcrete work was not damaging homes and yards. ACR also encountered an area of retaining wall where the cap was directly above a residential balcony. To perform removals and shotcrete repairs without damaging property below, two stages of protection were deployed. First, ACR installed a fabric tarp along the guardrail of the trail to keep debris from travelling over the side. Additionally, the area designated for repair was framed to ensure that all chipping debris would remain on the trail-side instead of falling to the balcony and property below. This one-sided formwork also gave the nozzleman something to shoot against. As ACR progressed along this 2.67 mile (4.29 km) jobsite, encountering different temperaments of residents, gaining permission to access the repair areas along the retaining walls ran the spectrum of difficulty.
